(Bulletin for Statehouse, Capitol Mall Employees October 9, 2001)

Department of Administration Construction Update No. 10

## **Concrete Poured for Step Support Beams, Curing Follows**

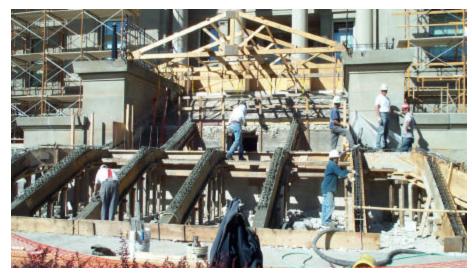
Workers began pouring concrete into the newly constructed support beams of the East Steps last Friday, removing the forms on Tuesday, (Oct. 9). Concrete now has to cure for a least a week.

The concrete support beams have been poured and forms have been stripped as part of the continuing work on the replacement of the East Steps of the Statehouse, as the First Phase of the **Idaho Capitol Restoration** effort continues.

The beams with their newly poured concrete now need to cure a minimum of seven days before other work can be built on top of the supports.
